*Severe Beach Erosion Caused  
by Permanent Beach Sand Loss  
Through Rollover Fish Pass  
Bolivar Peninsula, Texas*

**September, 1999**

**For  
J. Martin Green  
and  
Alan McNeill  
Attorneys at Law**

**Richard L. Watson, Ph.D.**  
**Consulting Geologist**  
*P.O. Box 1040*  
*Port Aransas, Tx 78373*  
*(361) 749-4152 (253) 981-0412 fax*

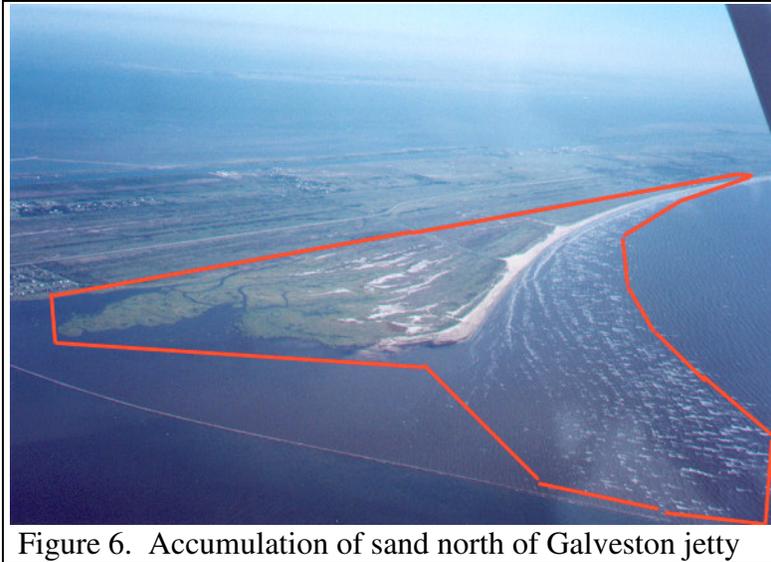
Figure 6. Accumulation of sand north of Galveston jetty

This huge accumulation of beach materials was carried west along the shore of Bolivar Peninsula and accumulated north of the jetty at the Galveston Entrance Channel is shown in Figure 6. All of the material enclosed in red was deposited since the jetty was built 123 years ago in 1876. This amounts to about 260,000 cu yd/yr. This is fairly close to the 200,000 cubic yards estimated to be lost to the

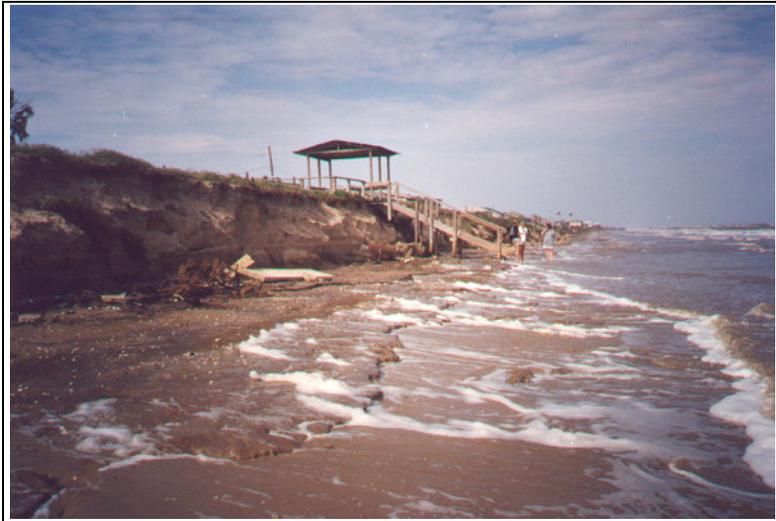
Figure 19 (Beach at Gordon House late summer 1995)

tropical storm Dean. Note the ledges of clay forming the beach instead of sand. This is very significant because it shows the shoreline eroded back so far inland, that there is no longer a thick sand body in the location of the beach.

Figures 19 and 20 show that even relatively mild

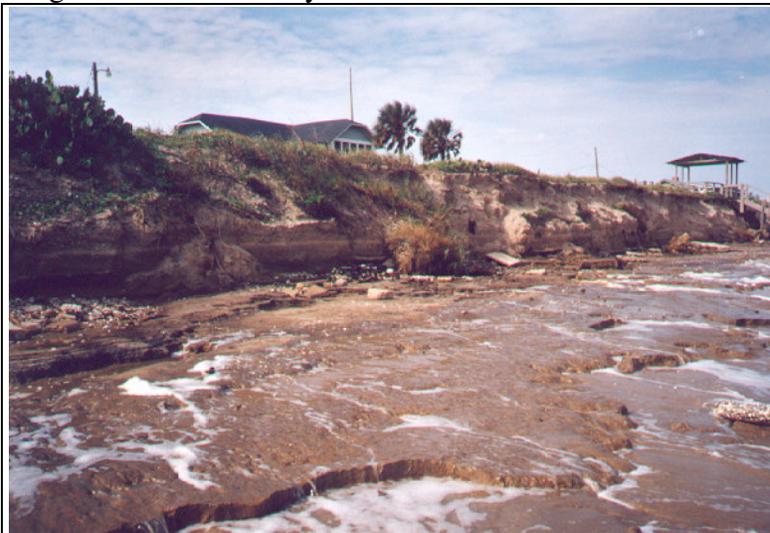
Figure 20 Late Summer 1995 at Gordon house

45 natural healing of the beach between major storms (Fig. 20).

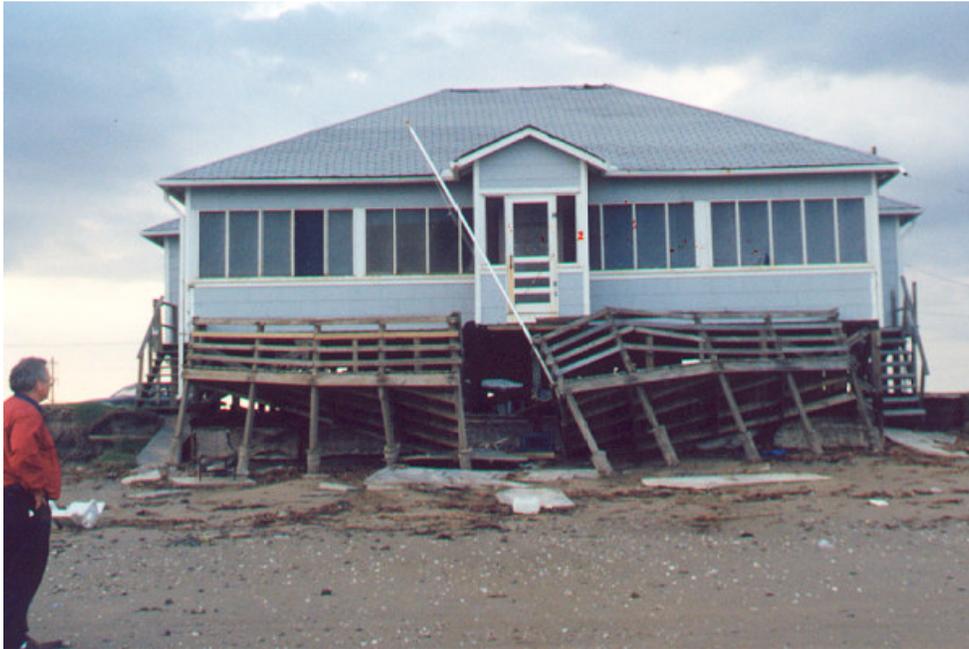
TexasCoastGeology.com  
**Green House 1998 (Post TS Frances)**

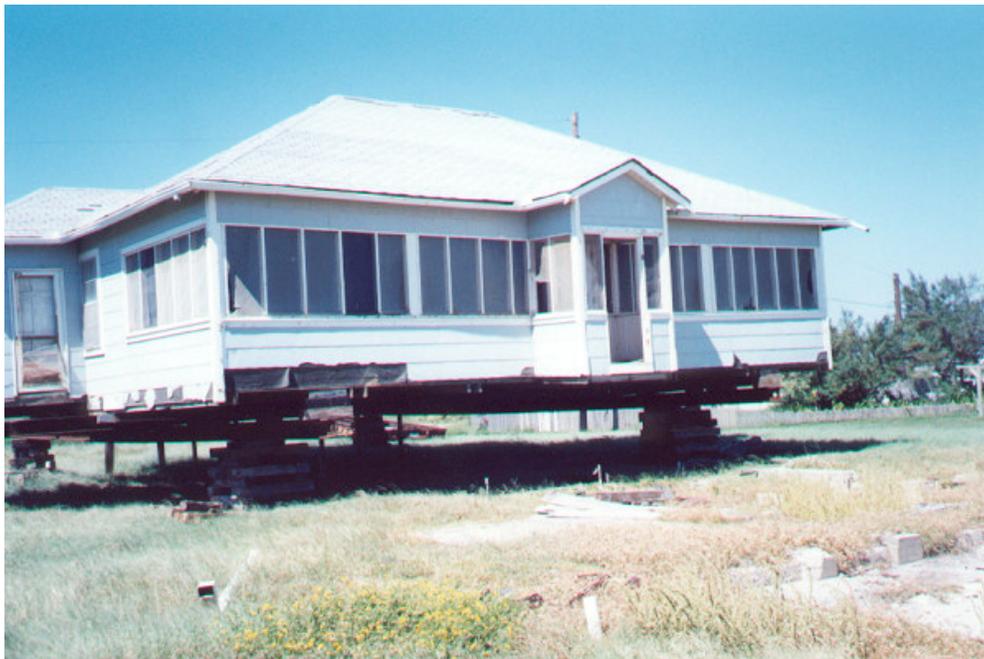
**Green House September 1999**

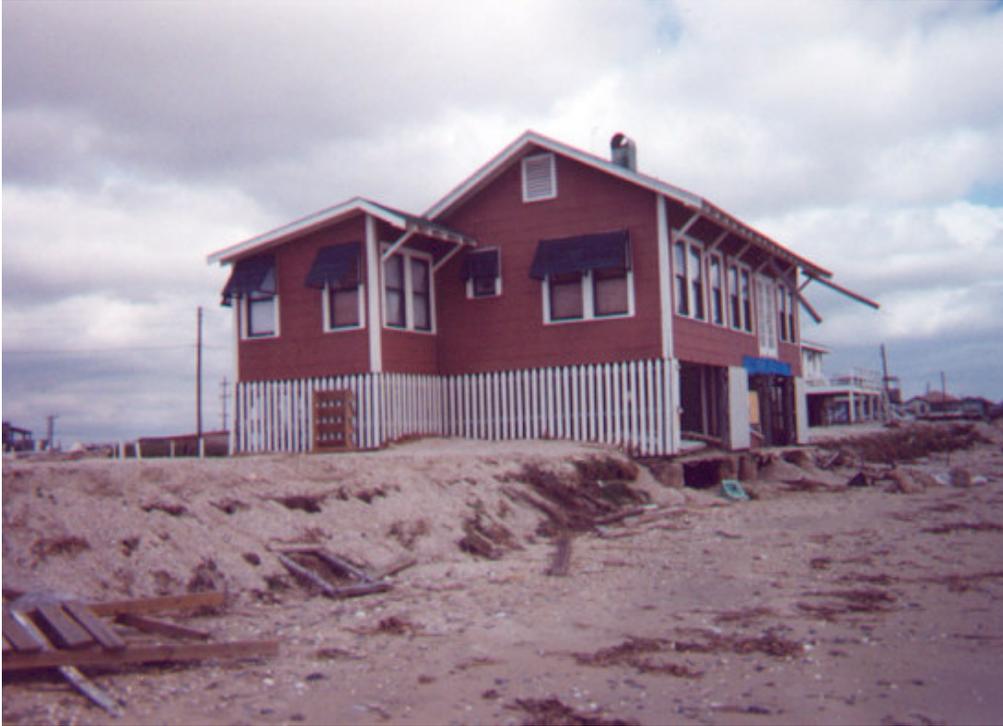
TexasCoastGeology.com  
**Seewald House Post Frances**

This house will not be moved because the owner does not own any land to the north.  
He will lose the house unless the beach is restored.

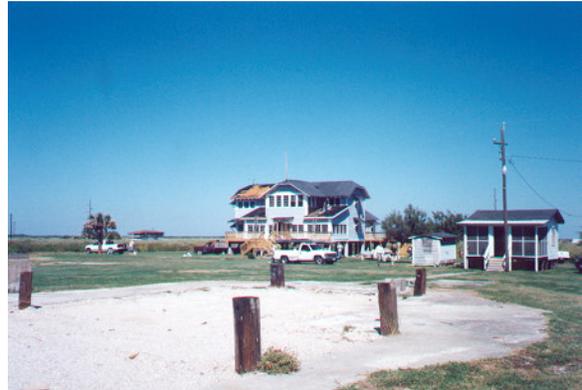
The picture to the right shows the house in 1998 before it was moved back 200 feet.

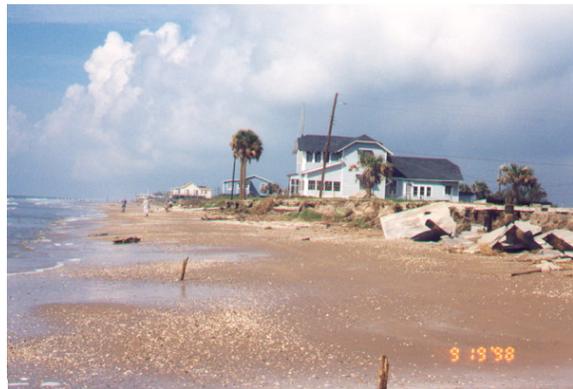
The above picture shows the Gordon house, *The Breakers* in September 1999 just after it has been moved 200 feet inland from its old location where the posts are in the foreground.

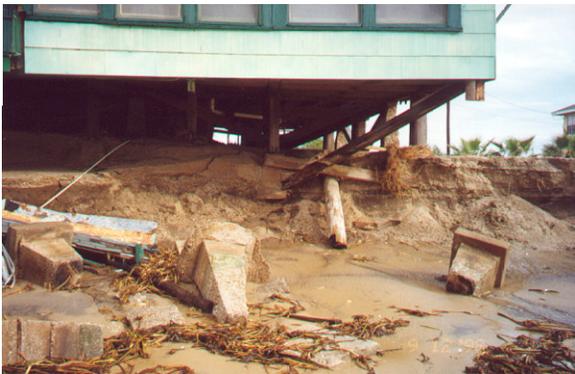
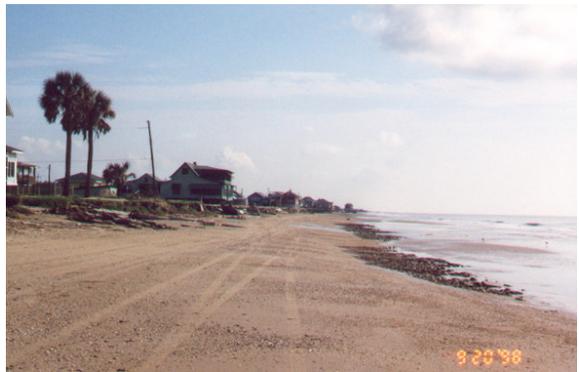
After Tropical Storm Frances, 1998

Erosion under Sauer house and beach in front of Gordon and Sauer houses showing exposed clay beds.

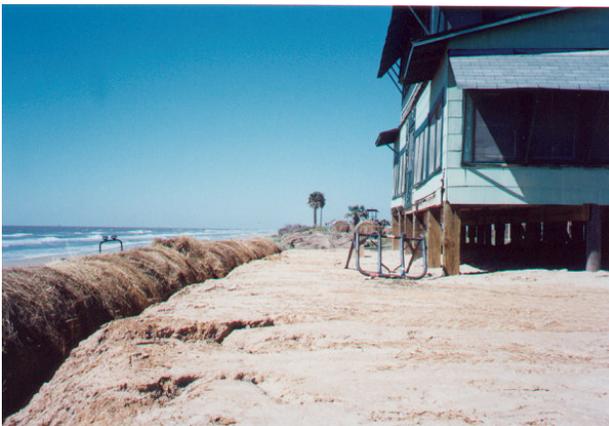
The Sauer house in September, 1999 after new support has been added and fill placed under and in front of house. The only erosion protection that is currently allowed is hay bales and fill. This will be rapidly eroded during the next storm. The beach sand lost through Rollover Pass needs to be replaced in a major beach nourishment program.

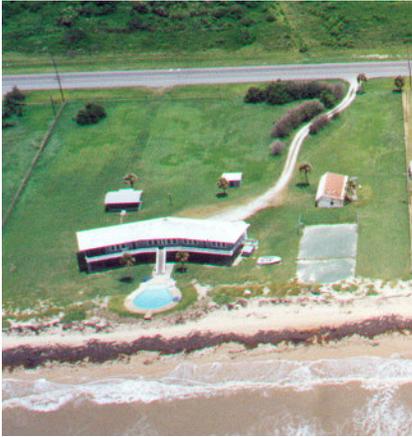
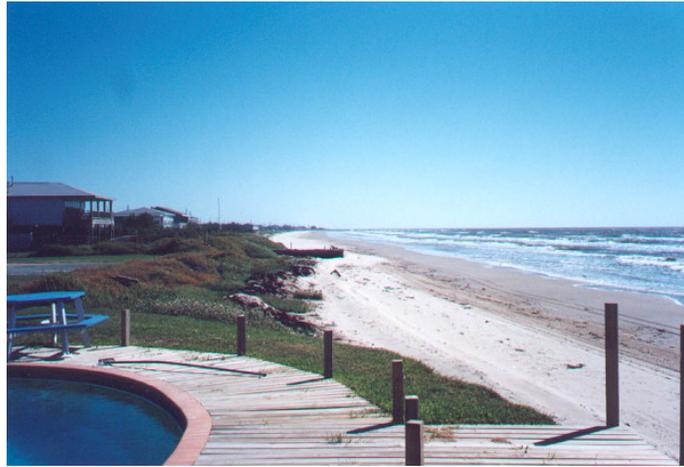
The photo on the left shows the vegetation line and scarp eroded right up to the pool in July 1999. The photo on the right shows how the pool actually extends beyond the scarp along most of the beach in September 1999.
